RE: August 2004 Monthly Report

1.5 Mile Reach Removal Action

GE-Pittsfield/Housatonic River Site

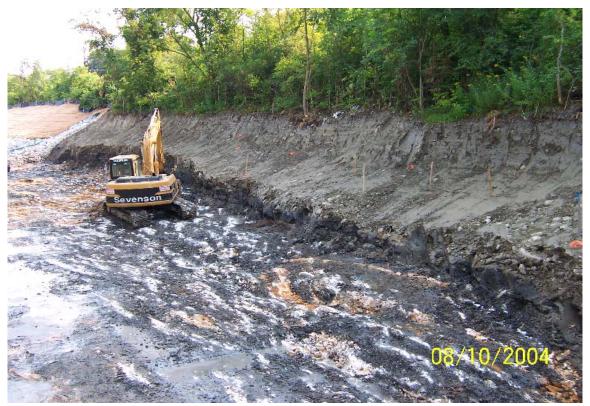
Photograph 1 – Cell 18E, Excavation Activities

completed. First, riverbank excavation activities were completed in Cells 18E and 19E. The excavated riverbank material from Cells 18E and 19E was placed into an Articulated Dump Truck (ADT) which transported and dumped the material into a roll-off box located in the river channel in Cell 18E. The material was then loaded into dump trucks by a long stick excavator located on the load out area on the riverbank of Cell 18W and hauled to the appropriate stockpile management area. The non-TSCA riverbank material pre-characterized for offsite disposal was transported to Area 64D; due to the large quantity of non-TSCA riverbank material precharacterized for offsite disposal generated during the excavation of Cells 18E and 19E riverbanks, the Area 64D stockpile management area was filled to capacity. Therefore, the Cell 18E and 19E non-TSCA pre-characterized material was transported to the Area 64B stockpile management area. The non-TSCA riverbank material uncharacterized for off-site disposal was transported to Building 65 stockpile management area (then relocated to Area 64C on 8/12/04); and the TSCA riverbank material was transported to Area 64A stockpile management area. (See Table 1 for quantities of material generated in the month of August 2004 and Table 2 for quantities of material generated to date). With a flood warning forecasted for Berkshire County, erosion controls were installed on the lower sections of the excavated riverbanks. This consisted of covering the excavated riverbanks with reinforced poly and filter stone.

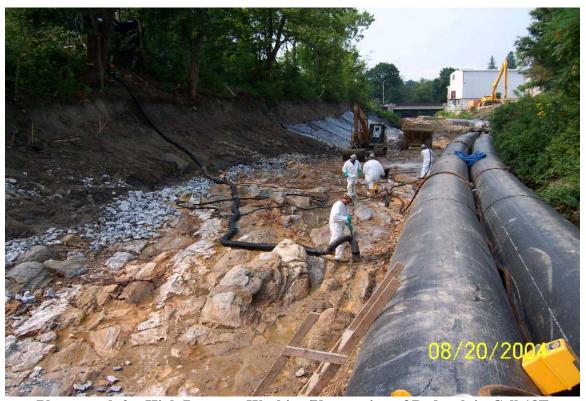
Photograph 2 – High Pressure Washing/Vacuuming of Bedrock in Cell 18E

Bedrock was encountered in the entire river bottom of Cell 18E and the upstream end of 19E. In addition to the standard excavation equipment, a small track excavator was used to access and remove the NAPL-impacted material and sediment from the areas of the river bottom where crevasses and depressions in the weathered bedrock were numerous. In most areas, there was less than 2-feet of sediment above the bedrock. Most of the bedrock within the riverbed in Cell 18E and upstream end of Cell 19E was stained with NAPL. The high pressure power washing of bedrock to remove any loose sediment and NAPL staining was initiated in Cell 18E and upstream end of Cell 19E. High pressure power washing of bedrock was supplemented with a vacuum truck to remove any residual sediment and NAPL from the bedrock. All water generated during the power washing was diverted to the water treatment system. All the residual sediment material was collected into roll-off boxes located in the riverbed and subsequently transferred to the water treatment system modutank.

dewatering was completed, the high pressure bedrock power washing and bedrock vacuuming was re-started. Since some of the bedrock in excavated areas in Cell 18E was not power washed before the flooding occurred and the flooding deposited a significant amount of material on the already washed bedrock, it was necessary to re-wash the entire riverbed of Cell 18E. All water generated during the power washing was diverted to the water treatment system. The residual sediment from the bedrock was removed by the vacuum truck. The more significant amounts of sediment were removed by the small track excavator. All the residual sediment material was collected into roll-off boxes located in the riverbed and subsequently transferred to the water treatment system modutank.

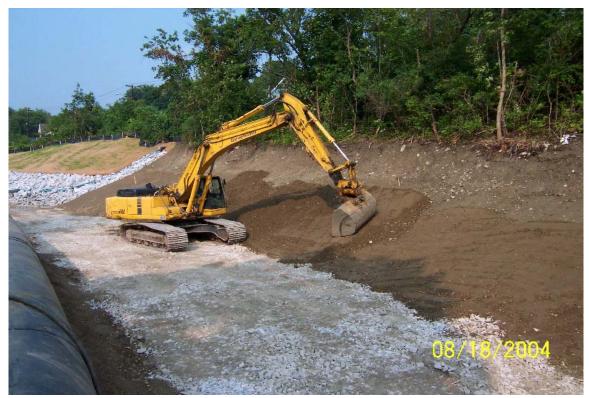
Photograph 3– Installation of Common Fill in Cell 18E

Due to the presence of bedrock within the entire riverbed of Cell 18E, excavation depths varied. Therefore, various backfill configurations were developed to meet the design requirements. Twelve-inch riprap was placed in low lying areas and depressions in the bedrock to bring the excavated surface up to grade. Areas of the riverbed where the excavation depth was greater than 3 feet were backfilled with a layer of common fill, filter material, and 12-inch riprap. Areas of the riverbed where the excavation depth was less than 2.5 feet were backfilled with a layer of filter material and 12-inch riprap. Areas of the riverbed where bedrock was encountered at very shallow depths were either backfilled with filter material or were left with the bedrock exposed. The riverbank was backfilled with a six-inch layer of common fill, a six inch layer of filter material and a twenty four-inch layer of 18-inch riprap up to the 1.5 year flood elevation, which ranges between 969.5 feet to 970.5 feet. The riverbank above those elevations was backfilled with common fill and a six-inch layer of top soil.

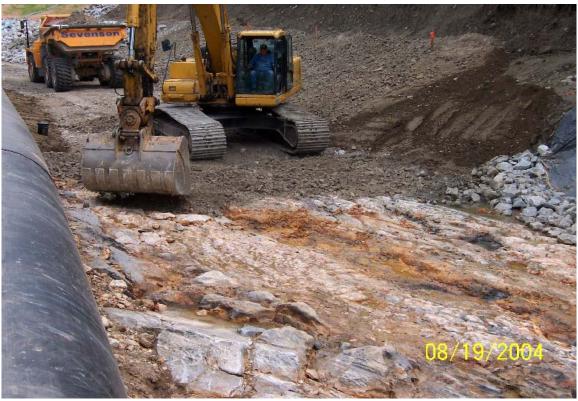
Photograph 4– Installation of Filter Stone in Cell 18E

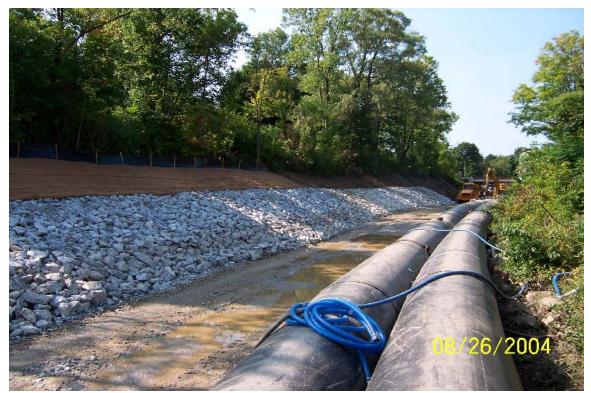
Photograph 5– Cell 18E Restored

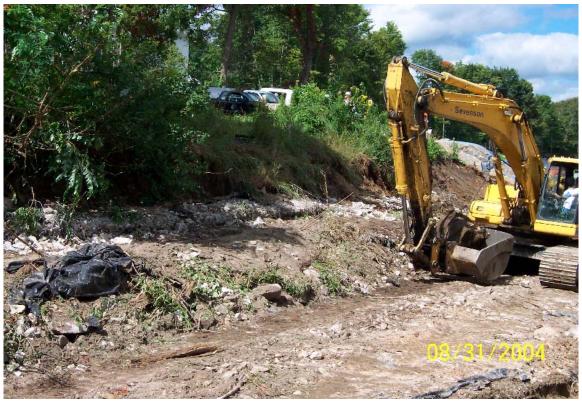
Photograph 6 - Gabion Basket Removal in Cell 18W

Once the 54-inch pipe was relocated, dewatering activates in Cell 18W were completed, and excavation activities in Cell 18W were initiated. A majority of Cell 18W and all of Cell 19W lower riverbank was previously remediated by GE in mid 1990's. Part of the GE riverbank restoration included the installation of reno mattresses and gabion baskets. Coconut logs were installed above the gabion baskets. The reno mattresses at the base of the gabion wall were being undermined compromising the structural stability of the reno mattresses/gabion baskets and therefore the riverbank itself. It was unknown how riverbed excavation activities in Cells 18W and 19W adjacent to the gabion basket wall would affect the stability of the reno mattresses/gabion baskets. To ensure long-term stability of the riverbank EPA decided it was prudent to remove the reno mattresses, the gabion baskets and the coconut logs. In order to achieve the 1.5 Mile riverbank clean up levels, additional riverbank soil would have to be removed to allow for a placement of a three foot layer of backfill. The lower riverbank will be

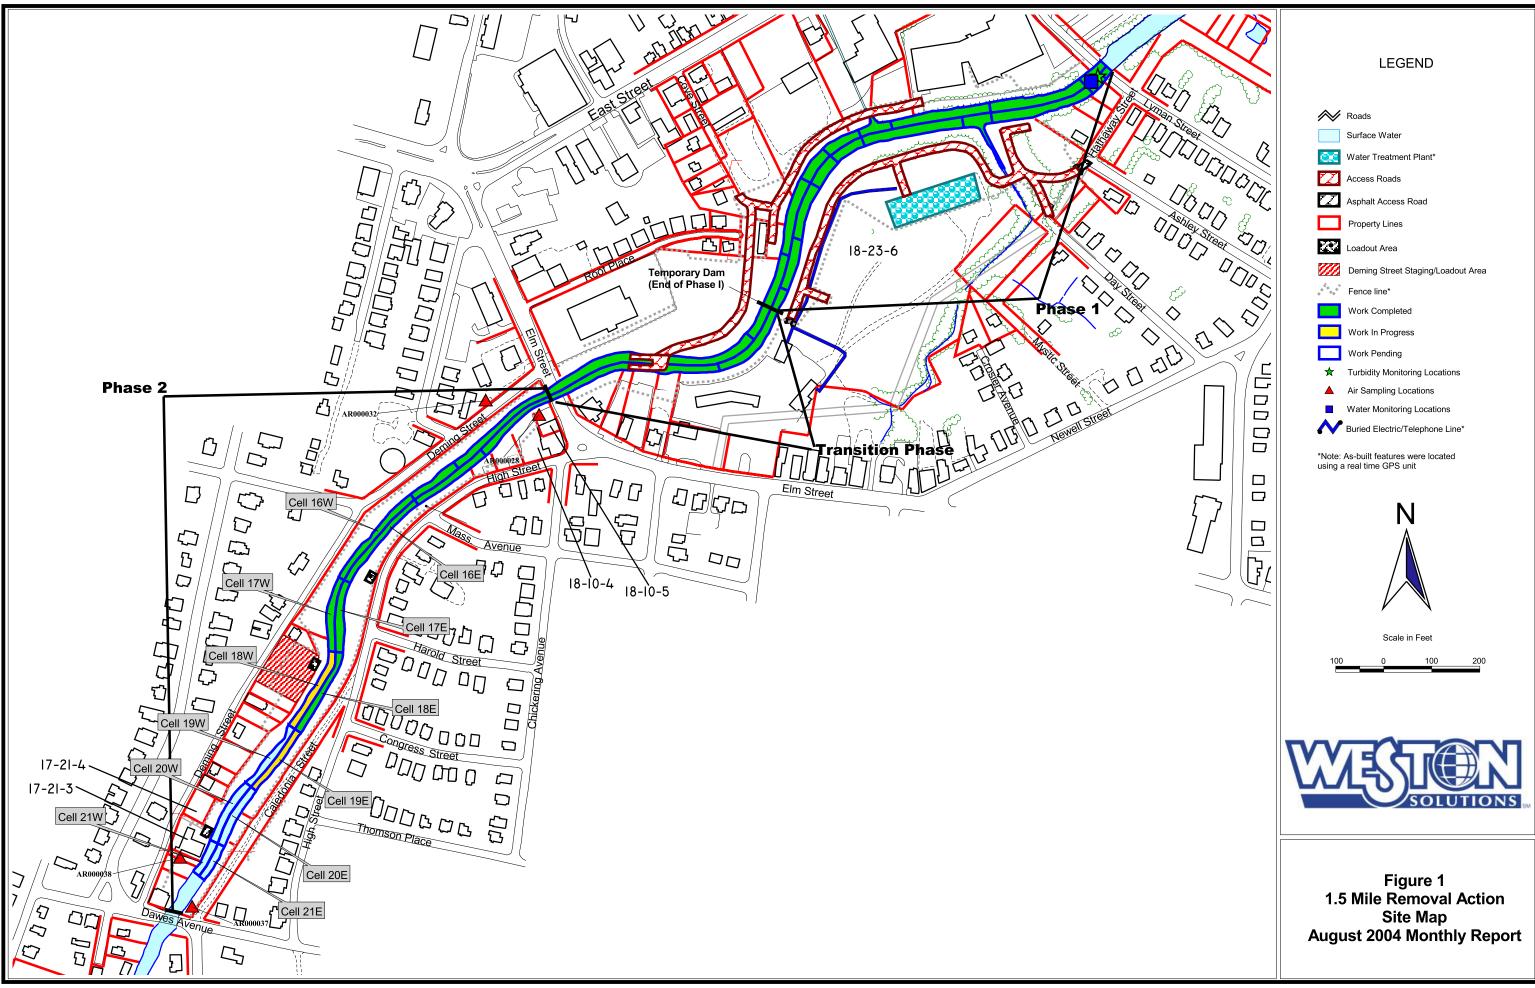
Figure 1 is a map of Phase 1, the Transition Phase and Phase 2 and includes the layout of all excavation cells, temporary dam, water monitoring locations, air sampling locations, access road locations, excavation load out locations, staging area locations, fence line location, the water treatment system pad location, and the utility trench location.

Refer to Figure 1 for an orientation of the excavation cells and their respective locations.
